Full Facility Roof Report

Kings Welding Works

Date : December 09, 2008

Facility: Administration Office
10111 Capital Road
Oak Park
Michigan
48237
USA

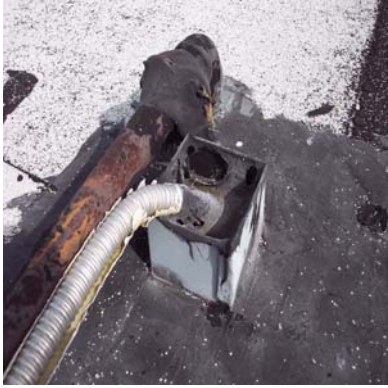
Type Of Defect	Severity	Quantity
Pitch Pan Fill Material Is Low	Medium	1
<p>Pitch pans should be completely filled with pourable sealer to maintain weathertightness around the penetration. As this material degrades over time, it will lose it's effectiveness against the weather and in this case, the pitch pan will also hold water. This pitch pan should be re-filled with the appropriate material.</p>

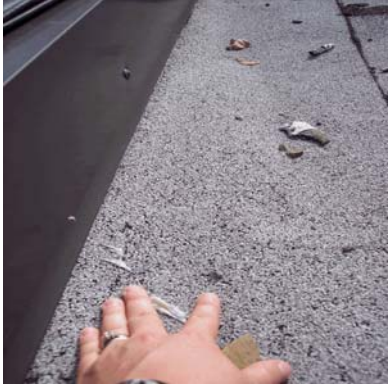
Blisters In Cap Sheet	High	1
<p>Large blisters in a roof membrane can cause seams or laps to open prematurely and/or stretching until eventually the membrane breaks open. Blisters should be repaired according to manufacturer standards.</p>

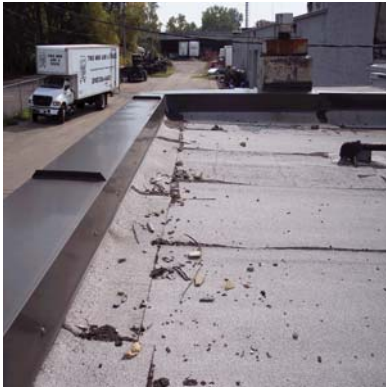
Miscellaneous Debris

Debris can damage the roof membrane by wearing away the protective surface granules or by retaining moisture. In some cases, debris can scratch or even tear the membrane during harsh weather conditions. All roof systems should be kept clean of any debris.

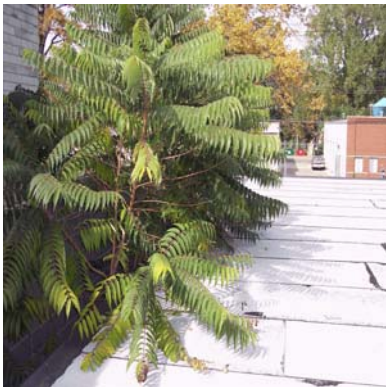
Vegetation/Overgrowth

Overgrown tree branches can damage a roofing membrane as they move during windy weather conditions. Leaves from the trees can also clog roof sumps causing damage to the roof assembly or worse, causing interior damage to walls or ceilings as well. All vegetation should be trimmed back from the roof system.

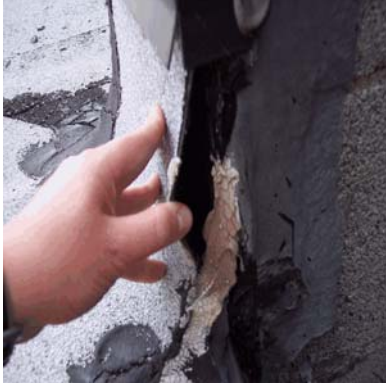
Type Of Defect	Severity	Quantity
Loose Base Flashing	High	1

Base flashing ends or laps should be firmly adhered to provide a weathertight roof system. This area in particular, should be readhered and terminated following proper manufacturer standards.

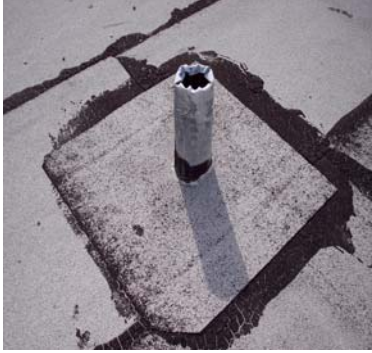
Projection	Soil stack	Target	Lead
<p>The soil stack has been flashed with a lead pipe boot and a 2 ply white modified flashing target. Appears to be in good condition.</p>
